Embedded Structural Health Monitoring with Additive Manufacturing: post processes to improve fatigue properties

Michaël Hinderdael¹, Dieter De Baere¹ and Patrick Guillaume¹ ¹Vrije Universiteit Brussel, Department of Mechanical Engineering, Brussels, Belgium

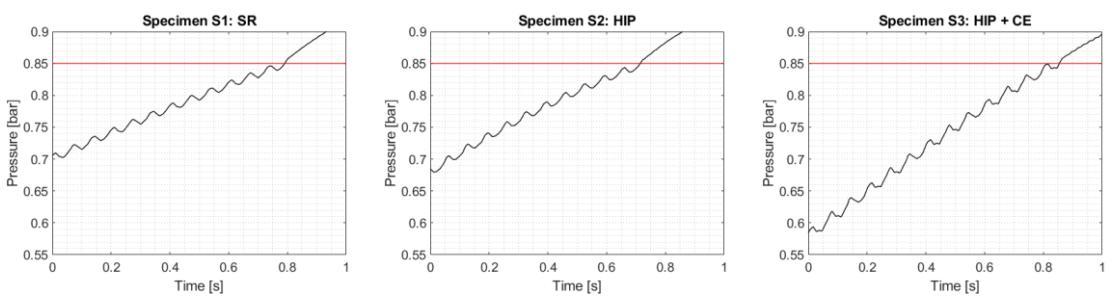
The eSHM system successfully detected the fatigue cracks before final fracture for all tested specimens. Figure 2 presents the last second of the pressure recording of the eSHM system in three different specimens.

Figure2: Crack detection by the eSHM system when capillary pressure exceeds 0.85bar. The figure depicts the last second of the pressure recording inside the capillary of (a) Specimen 1 (SR) (b) Specimen 2 (HIP) and (c) Specimen 3 (HIP + CE).

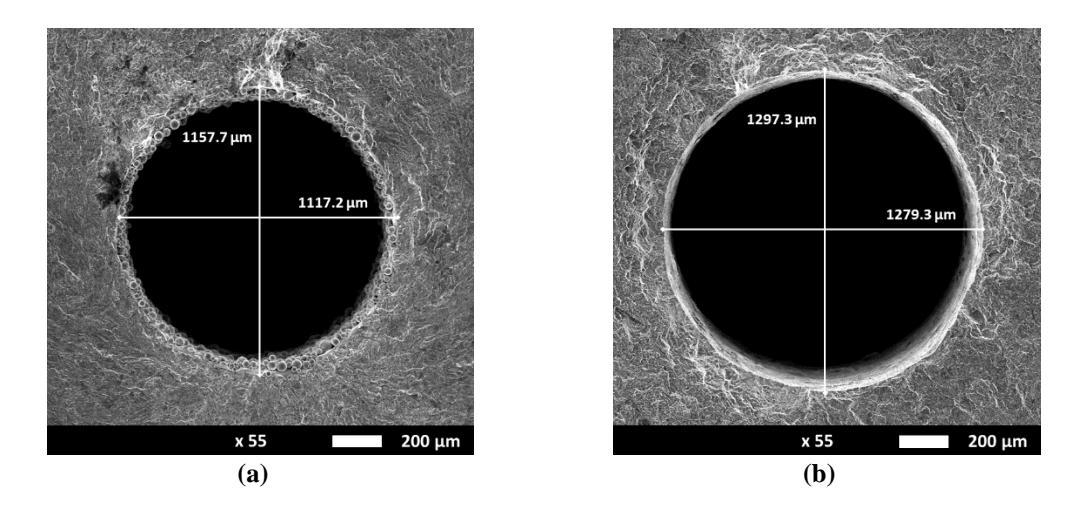
The fatigue tests results are summarized in Table1. The fatigue performance of the Ti-6Al-4V specimens with different post processes largely varied. Specimen 1 (SR) failed at a stress level of 600 MPa due to a subsurface defect. The hot isostatic pressed specimen (Specimen 2) outperformed the stress relieved specimen and only failed at a stress level of 818 MPa. As concluded from the fracture analysis, fatigue initiation occured at the capillary surface which is likely related to the higher surface roughness of this as printed surface. Since it is undesired that the integrated eSHM system causes fatigue initiation, Specimen 3 was post processed using both a HIP and CE procedure in order to reduce the capillary surface roughness. The improvement of the capillary surface roughness can be seen in Figure3. This surface roughness reduction resulted in a further increase of the fatigue strength (1130 MPa), a stress level at which a substantial portion of the test specimen has already been plastically deformed. Fatigue initiation did not occur on the capillary surface, but on the external surface of the four-point bending specimen. The eSHM system can be integrated inside Ti-6Al-4V without having an impact on the fatigue properties of the test specimen.

Figure3: Fractographic analysis is based on Scanning Electron Microscope (SEM) images of the fracture Surface. (a) Specimen 2: The surface roughness on the capillary initiated fatigue. (b) The capillary surface roughness has been reduced by the CE process.
